**RESERVE FUND STUDY**  
**TERRACES AT WALHALLA CONDOMINIUM ASSOCIATION**  
**COLUMBUS, OHIO**

*DECEMBER 2014*

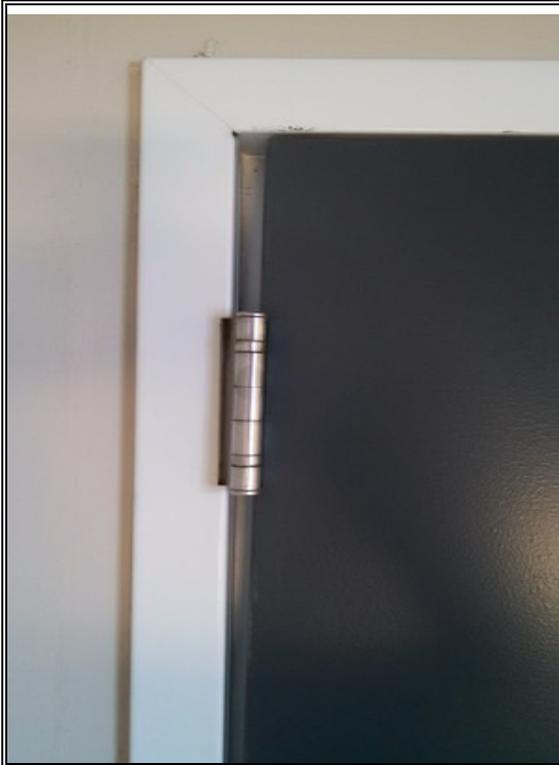
**Photo Number**  
**11**

Except as noted, the interior lobby, halls, workout room and mechanical equipment rooms appear to be in good condition. There are doors to the fire escape stairwells which do not close properly.

**Description:**  
Fire/exit door  
which does not  
close.

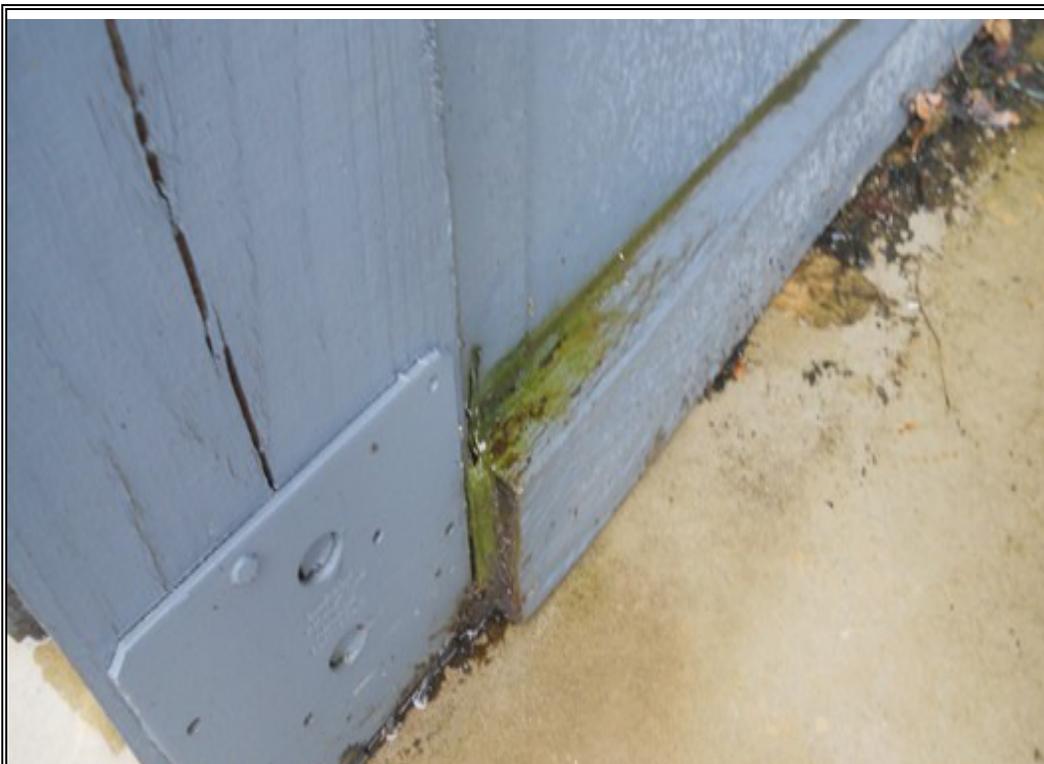
**Photo Number**  
**20**

**Description:**  
Close-up of wall  
showing  
deterioration.

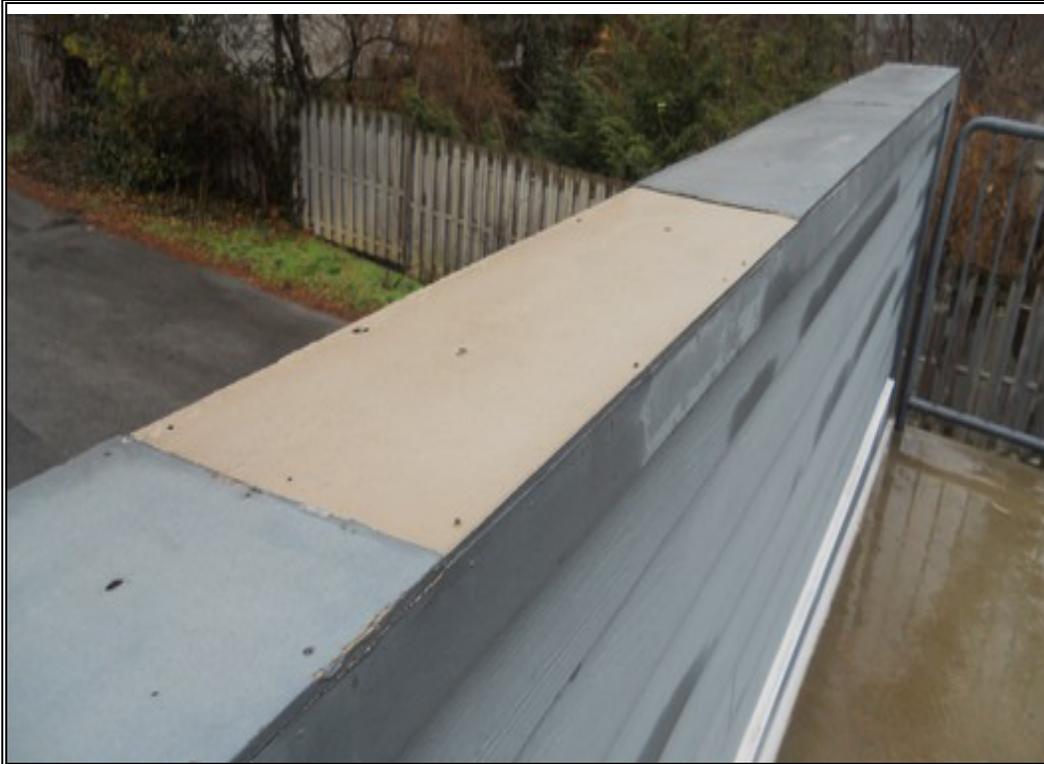
**Photo Number**  
**21**

**Description:**  
Portion of  
fiberboard cap  
having been  
replaced.

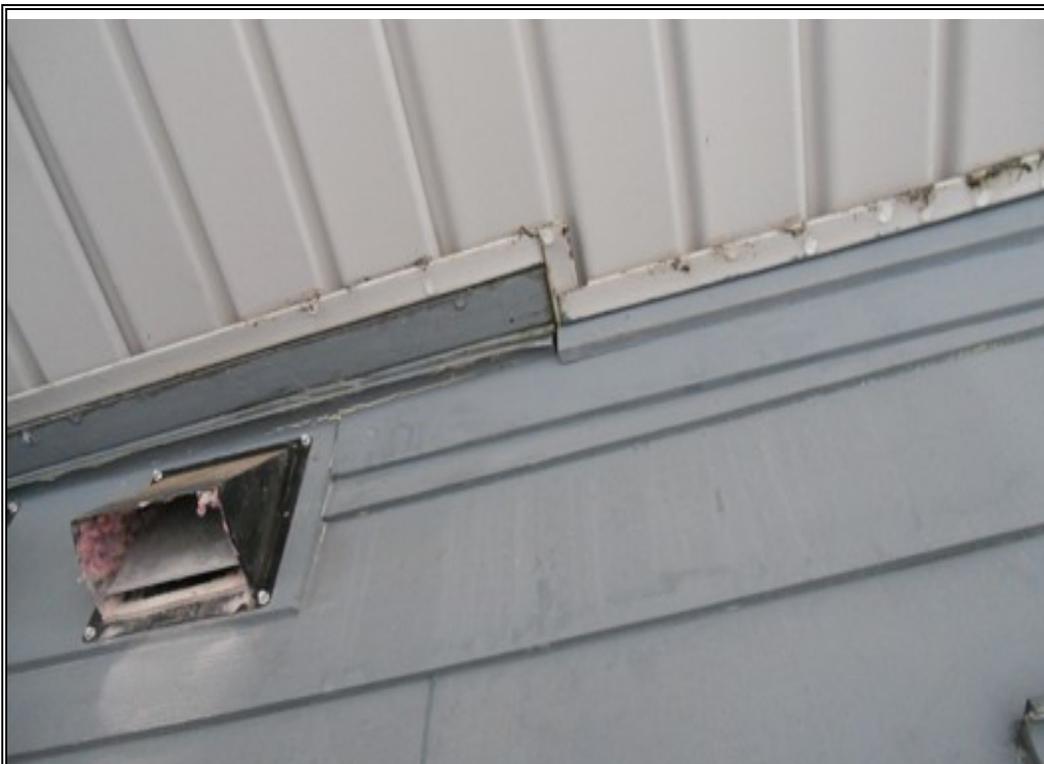
**Photo Number**  
**22**

**Description:**  
Ceiling under  
decks showing  
water penetration.

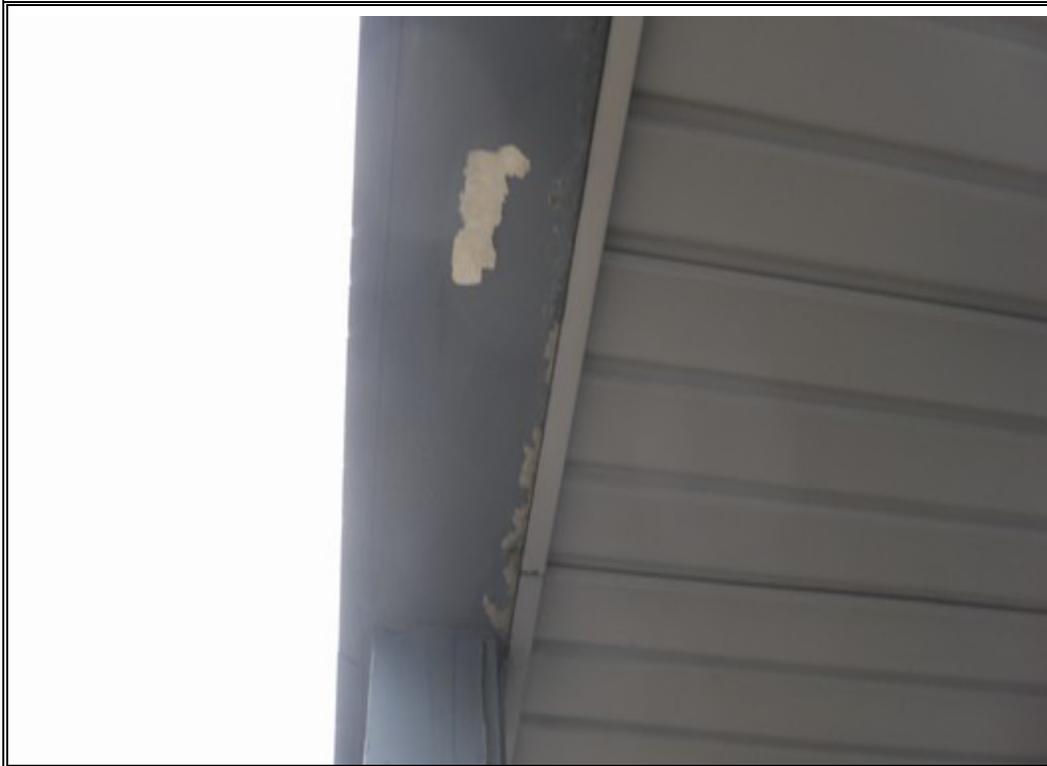
**Photo Number**  
**23**

**Description:**  
Under side of deck  
showing peeling  
paint and  
deterioration.

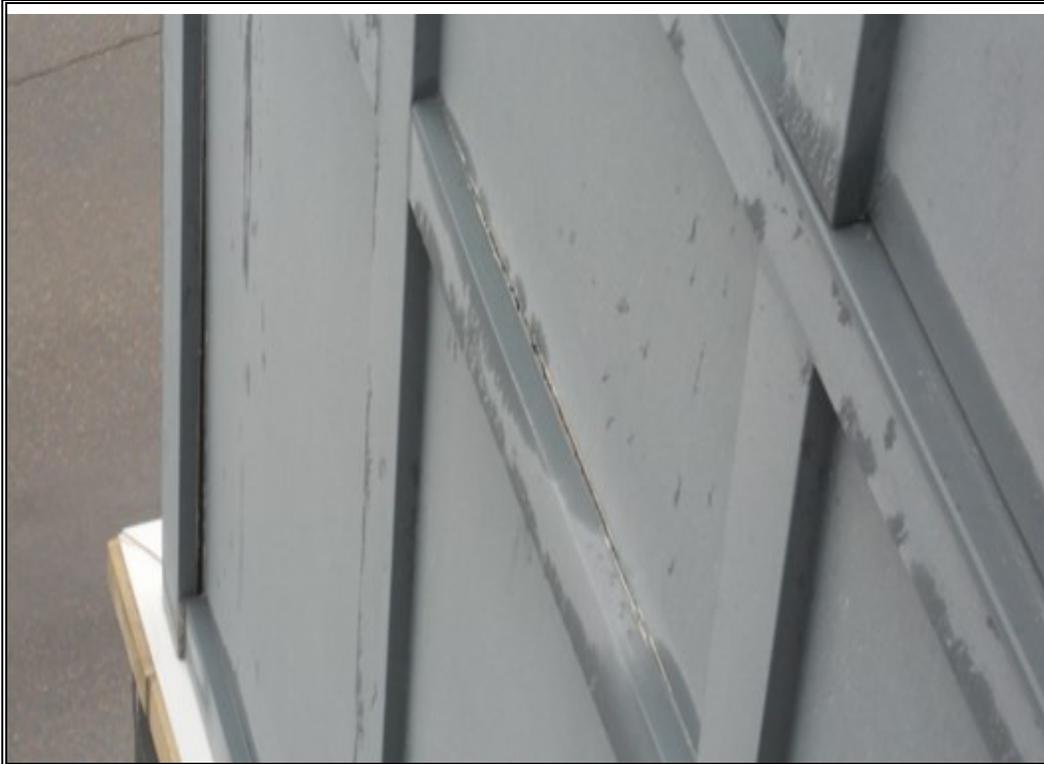
**Photo Number**  
**25**

**Description:**  
Area of fiberboard  
trim pulling away  
from wall.

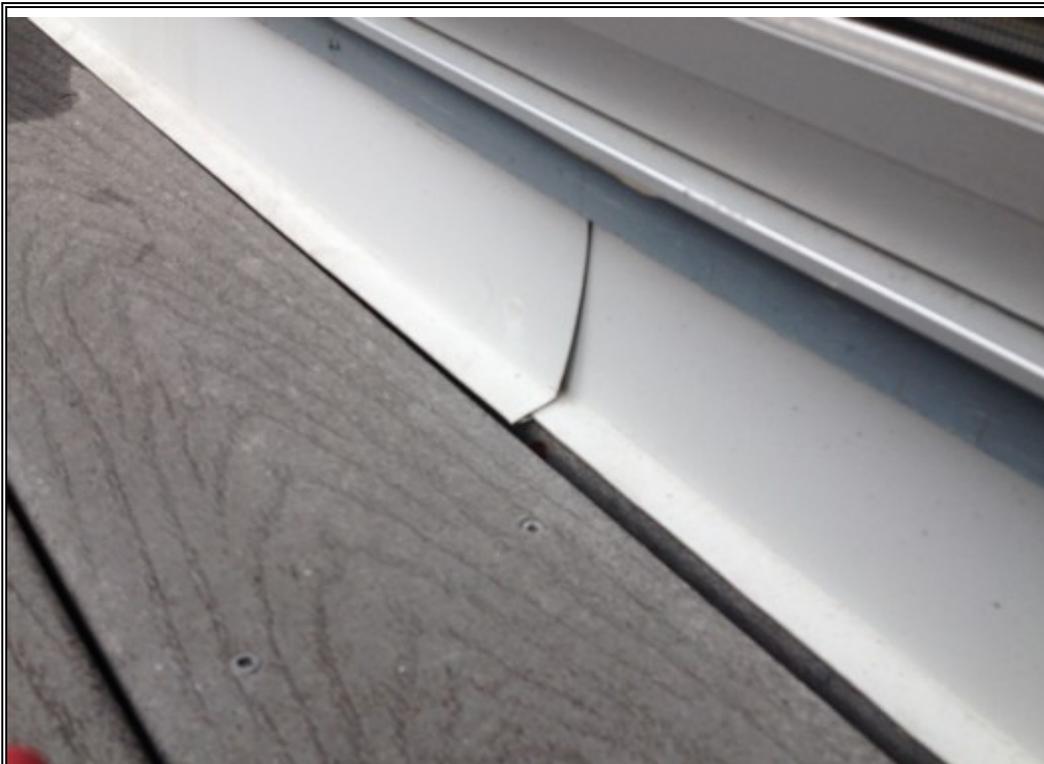
**Photo Number**  
**26**

**Description:**  
Portion of siding  
pulling away from  
wall.

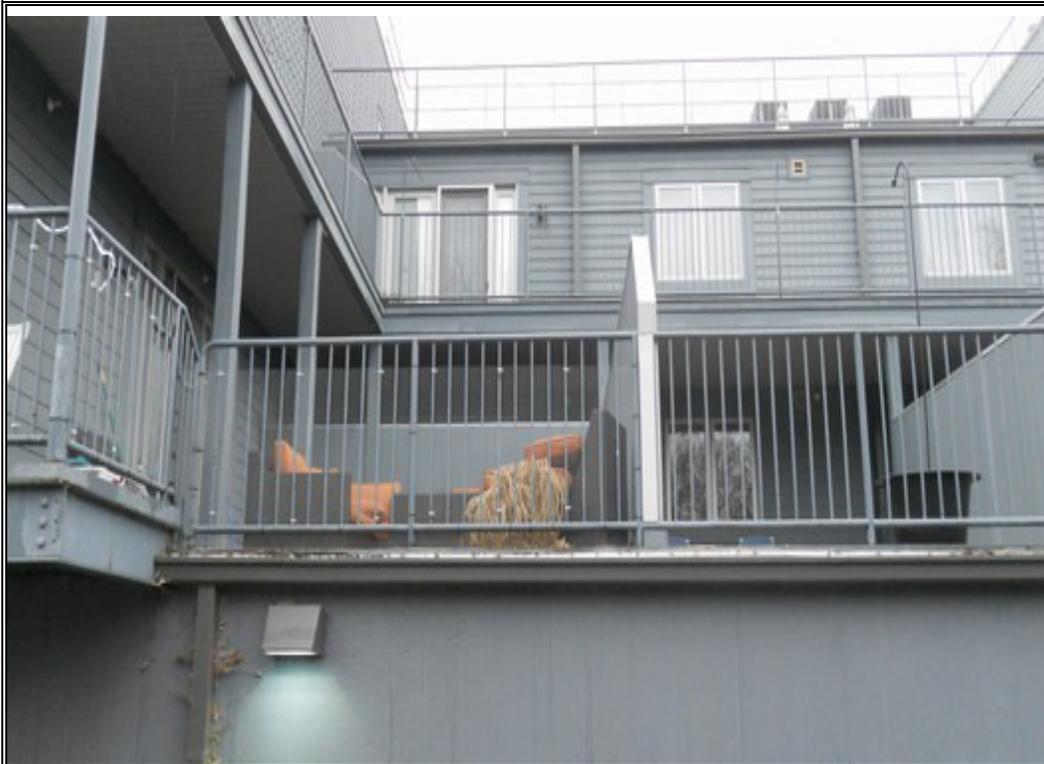
**Photo Number**  
**27**

**Description:**  
Area of second floor terrace and gutter where water leaks into garage.

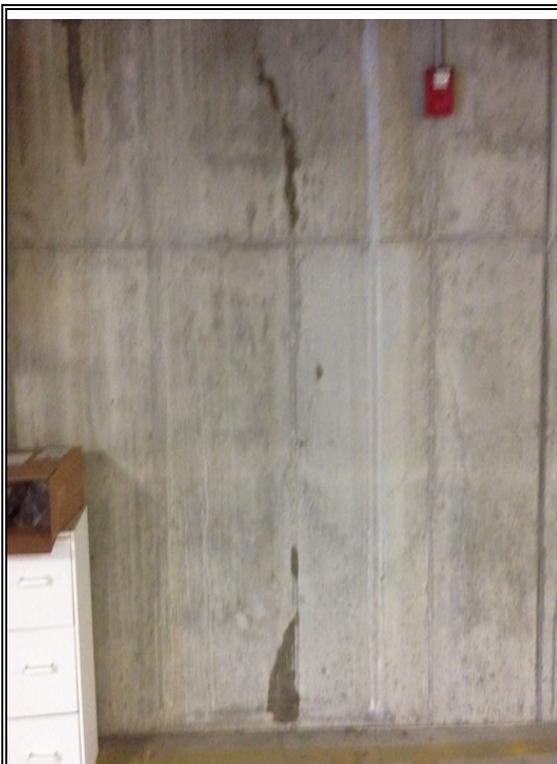
**Photo Number**  
**28**

**Description:**  
Inside of garage where water is penetrating.

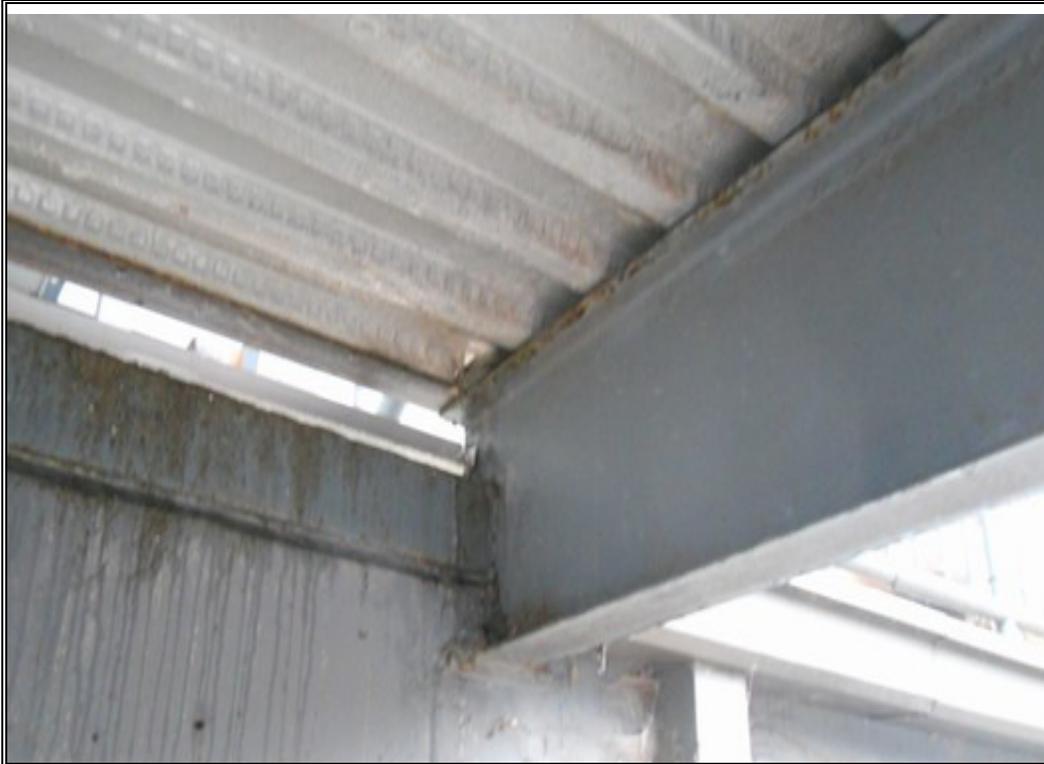
**Photo Number**  
**29**

**Description:**  
Steel support on  
underside of decks  
showing rust.

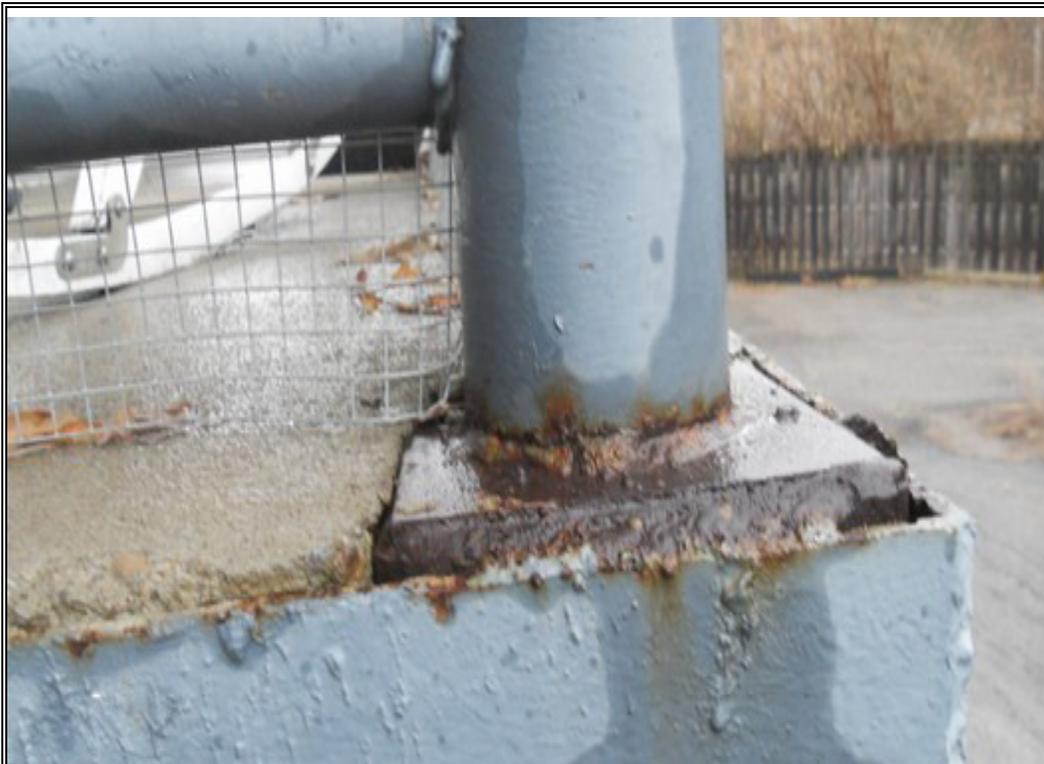
**Photo Number**  
**30**

**Description:**  
Railing post detail  
showing rust.

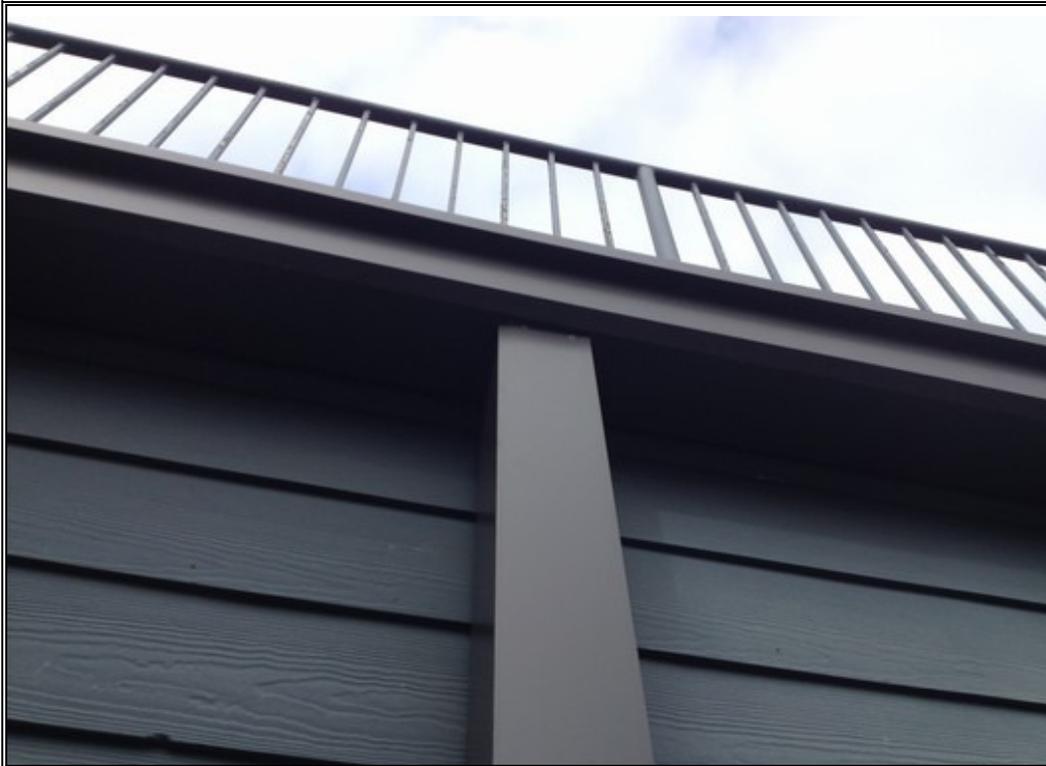
**Photo Number**  
**31**

**Description:**  
Fourth floor  
terrace gutter and  
drain,

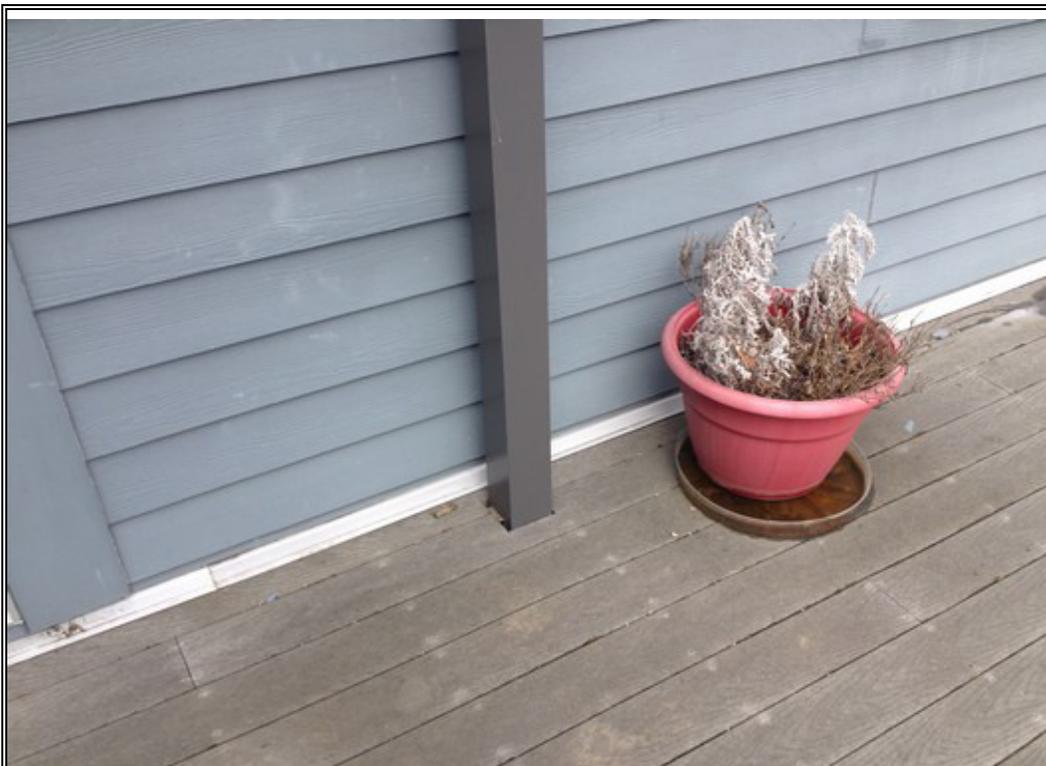
**Photo Number**  
**32**

**Description:**  
which runs through  
third floor deck,

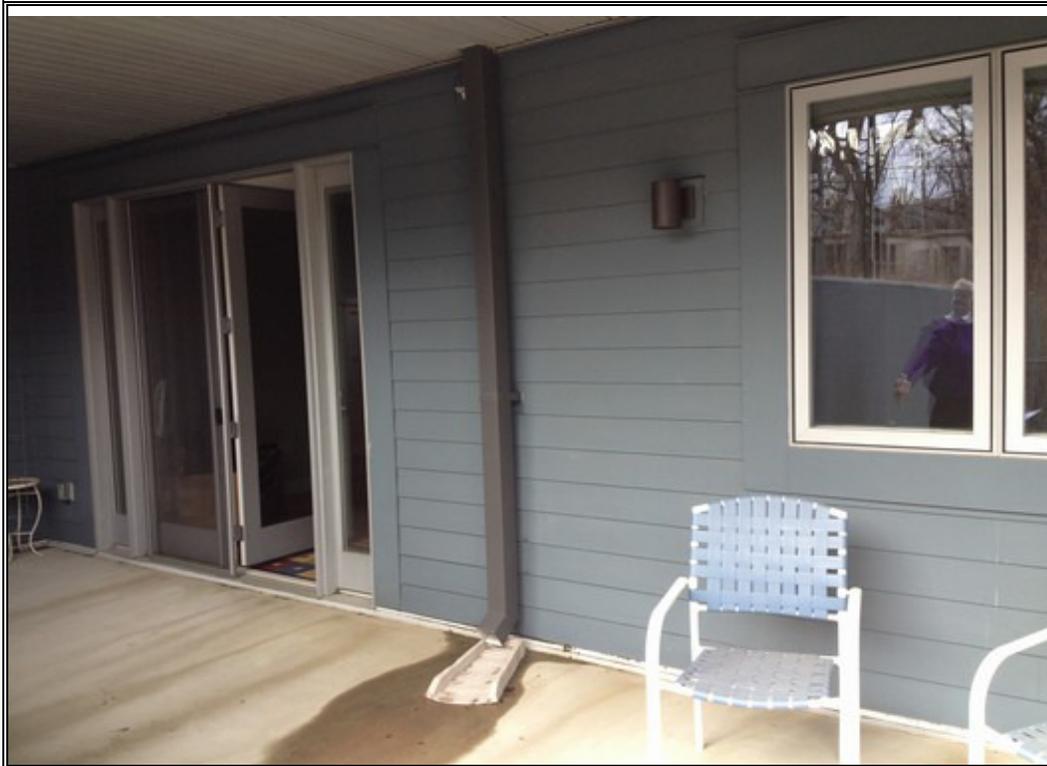
**33**

And deposits onto and across second floor patio.

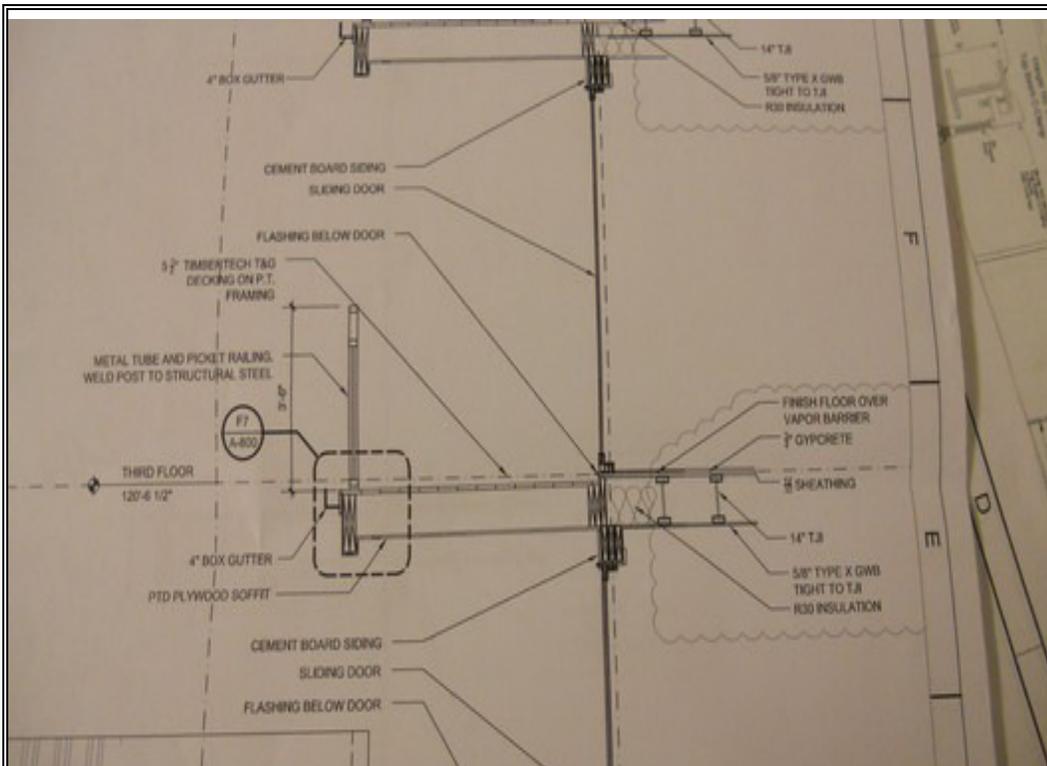
Detail of typical balcony. The deck is not water proof and there is no continuous vapor barrier at the building.

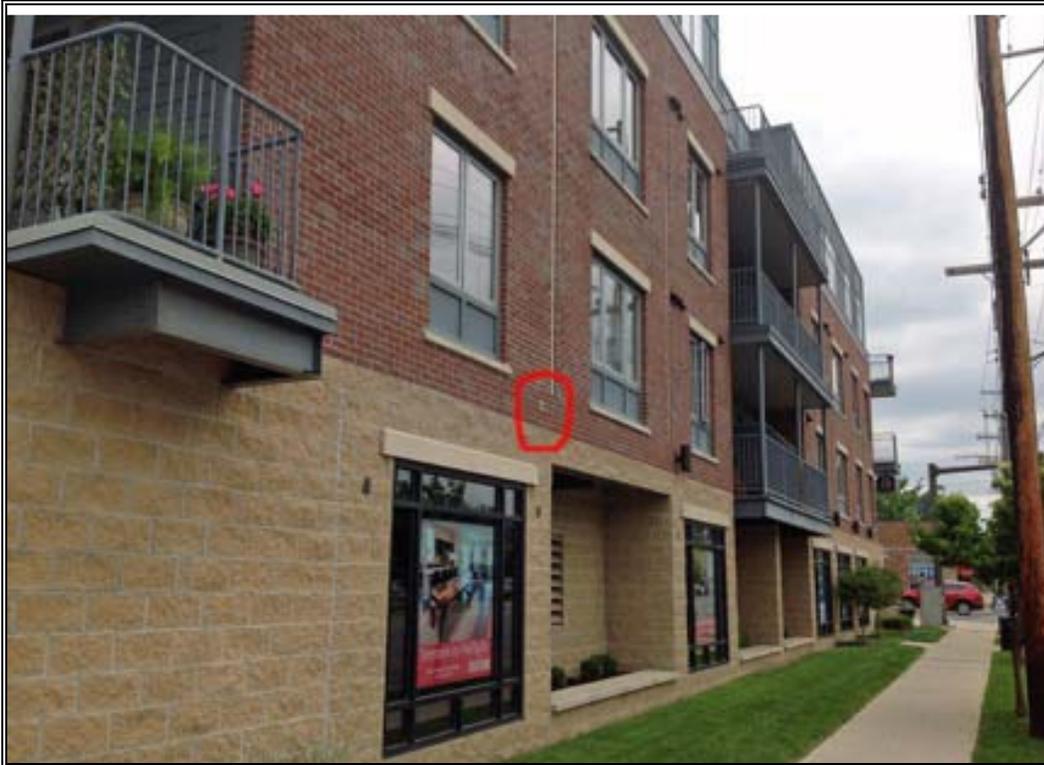
**Photo Number**  
**35**

**Description:**  
Missing light  
fixture.
