RESERVE FUND STUDY
TERRACES AT WALHALLA CONDOMINIUM ASSOCIATION
COLUMBUS, OHIO

DECEMBER 2020

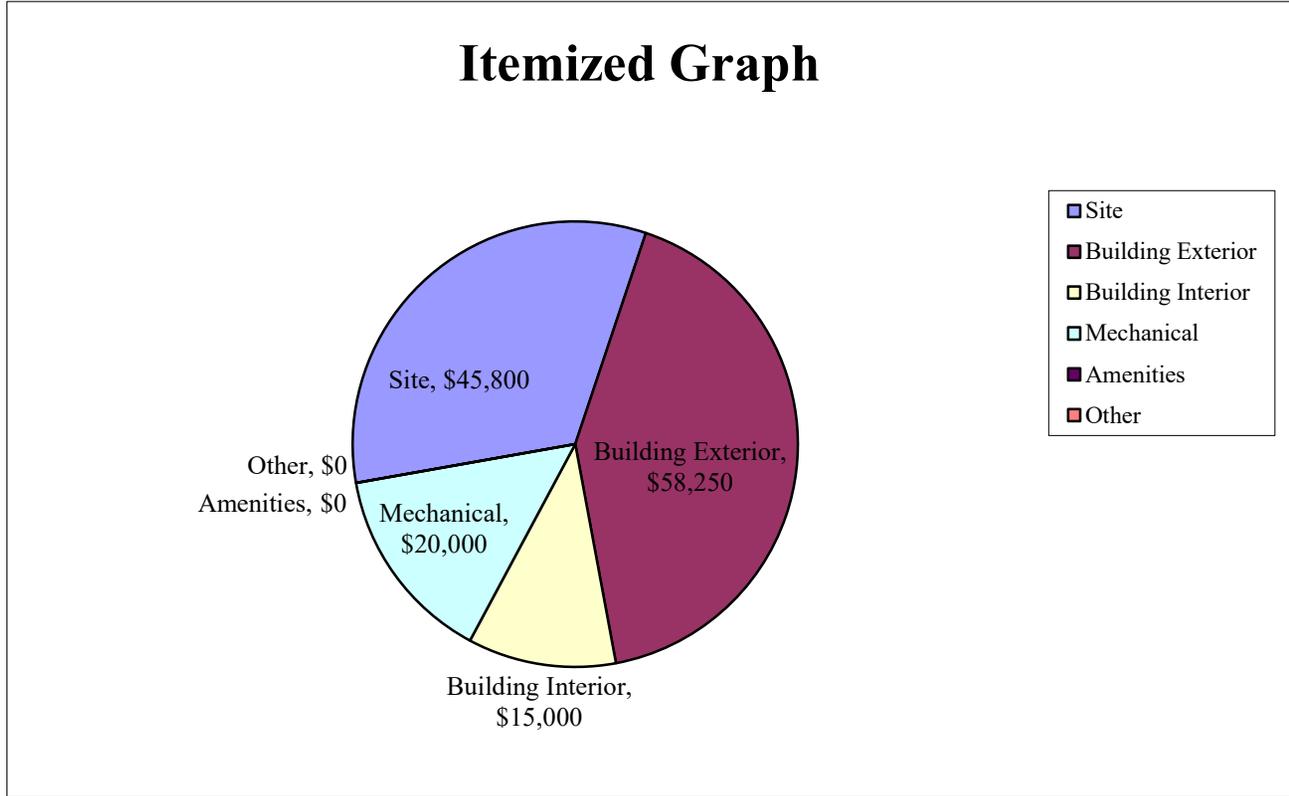
Itemized Graph

Categories	Totals
Site	\$45,800
Building Exterior	\$58,250
Building Interior	\$15,000
Mechanical	\$20,000
Amenities	\$0
Other	\$0
Total	\$139,050

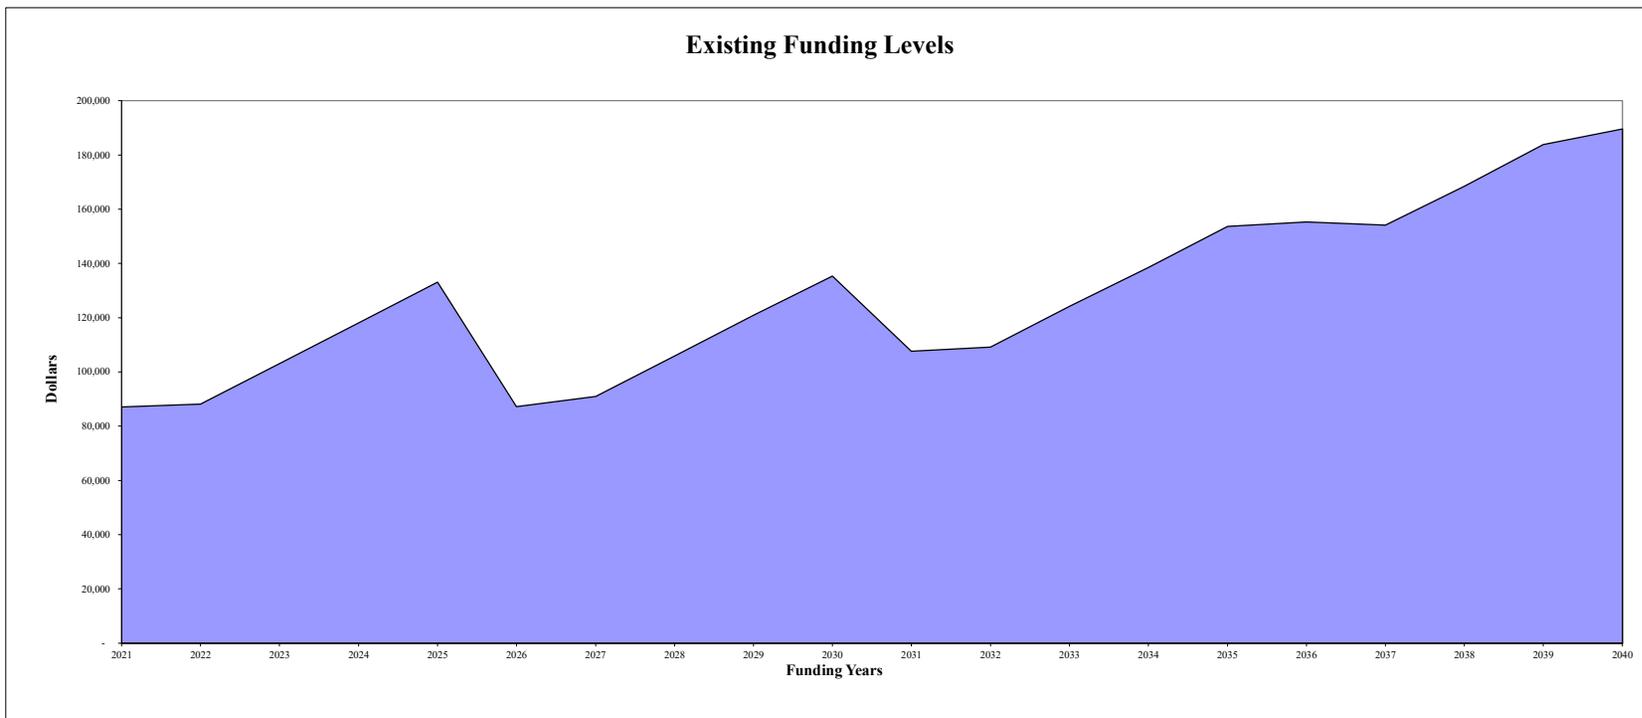
Year:	2021	2022	2023	2024	2025	2026	2027	2028	2029	2030	2031	2032	2033	2034	2035
Year Number:	1	2	3	4	5	6	7	8	9	10	11	12	13	14	15
End of Year Reserve Fund Balance	87,050	88,108	103,021	118,008	133,070	87,132	90,913	105,839	120,840	135,273	107,651	109,124	124,142	138,481	153,646
Capital Expenditures:	7,500	13,780	-	-	-	60,772	11,072	-	-	640	42,557	13,470	-	749	-
Total Revenue (all sources)	14,833	14,838	14,913	14,987	15,062	14,833	14,852	14,927	15,001	15,073	14,936	14,943	15,018	15,089	15,164

Year:	2036	2037	2038	2039	2040
Year Number:	16	17	18	19	20
End of Year Reserve Fund Balance	155,311	154,089	168,451	183,765	189,628
Capital Expenditures:	13,507	16,389	877	-	9,481
Total Revenue (all sources)	168,818	170,478	169,327	183,765	199,109
